Asbestos Survey

Community-Wide Assessment Grant
EPA Cooperative Agreement BF-00E02281-0
6010, 6016-6018, & 6024 Montgomery Road
Cincinnati, Ohio 45213

March 15, 2019

Terracon Project No. N1197037

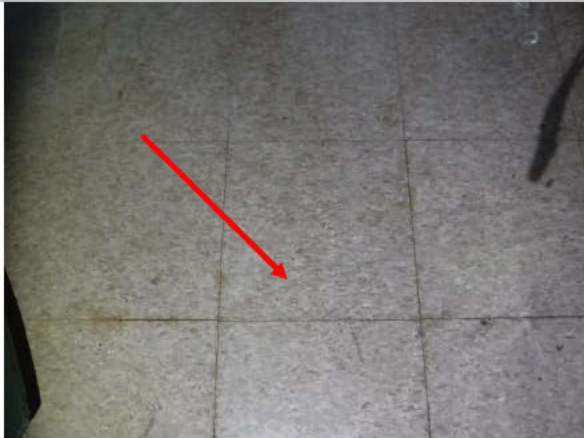
Photo #1 HA 1: Asbestos-Containing 12"x12" Beige Floor Tile with Black Mastic,

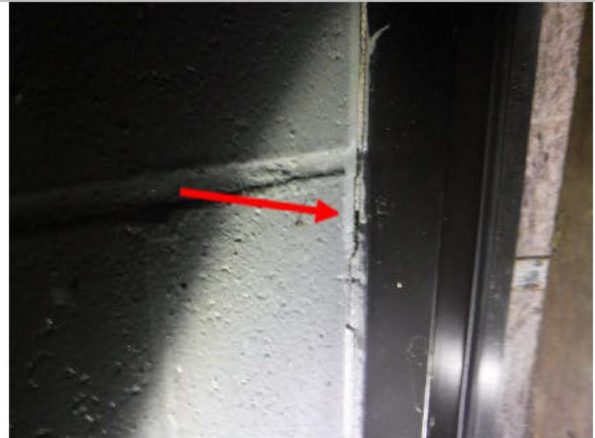
Photo #2 HA 3: Asbestos-Containing Black Interior Window Caulking.

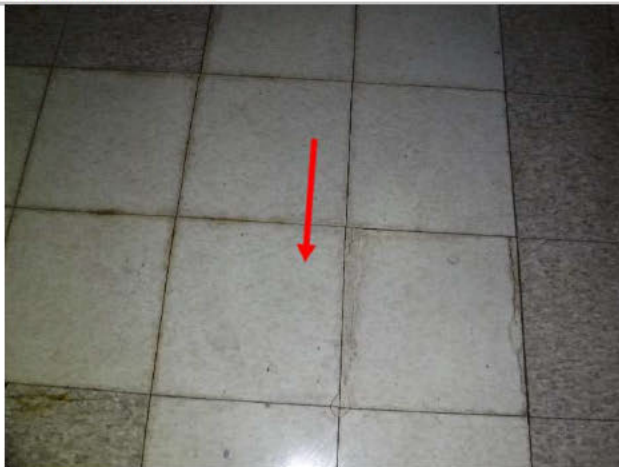
Photo #3 HA 4: Asbestos-Containing Black Mastic Beneath Non-Asbestos-Containing 12"x12" Cream Floor Tile Patch.

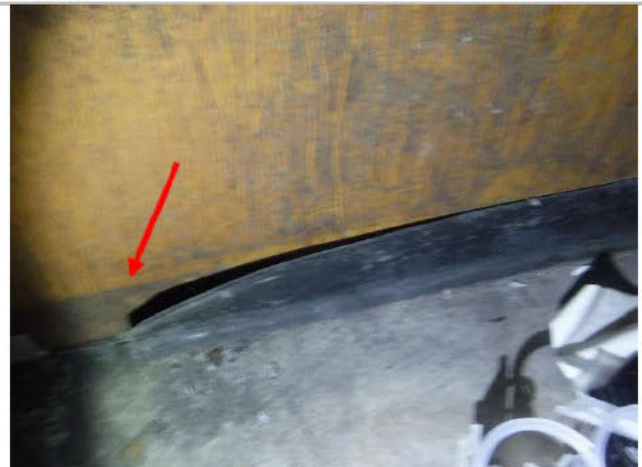
Photo #4 HA 7: Asbestos-Containing (<1% by PLM) Brown Mastic Beneath Non-Asbestos-Containing 4" Black Cove Base.

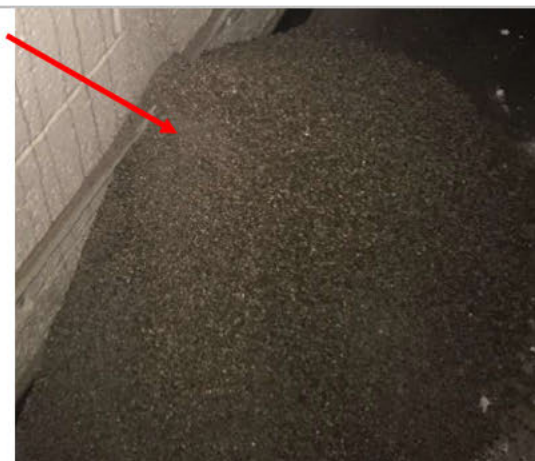
Please note that the vermiculite fill material was encountered in the perimeter concrete masonry unit (CMU) block walls at 6010 Montgomery Road. The vermiculite samples were also analyzed using the PLM method with point count. Determining actual asbestos-content in vermiculite can be difficult using traditional PLM with point count. The USEPA recommends treating vermiculite as if it contains >1% asbestos unless an additional alternative method such as transmission electron microscopy (TEM) can confirm <1% asbestos-content or deny asbestos-content.

Photo #5 HA 14: Asbestos-Containing (<1% by PLM) Vermiculite Fill Insulation (inside CMU blocks).

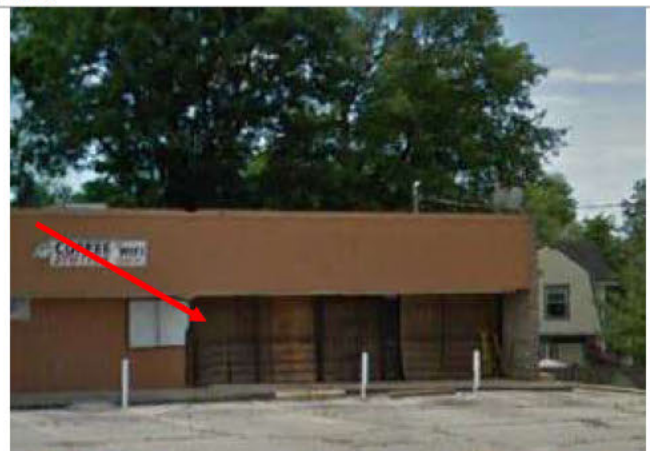
Photo #6 HA 16: Asbestos-Containing Exterior Black Window Caulking.

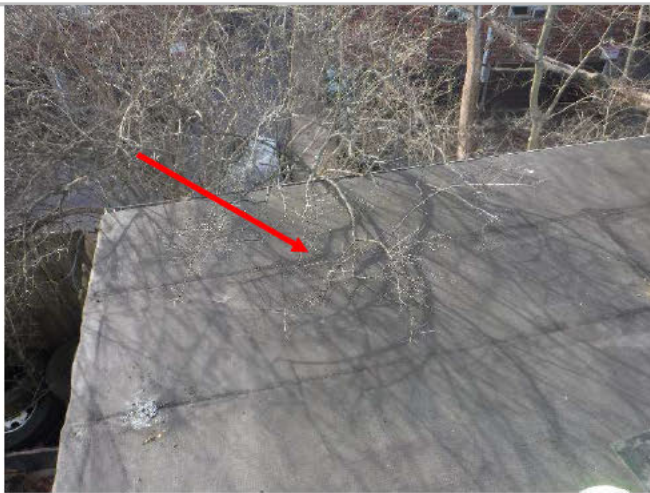
Photo #7 HA 20: Asbestos-Containing Asphalt Roof.

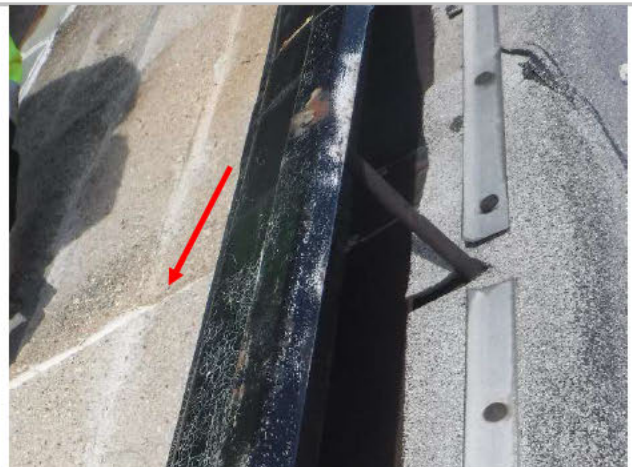
Photo #8 HA 22: Asbestos-Containing Black Mastic Beneath Non-Asbestos-Containing Caulking.

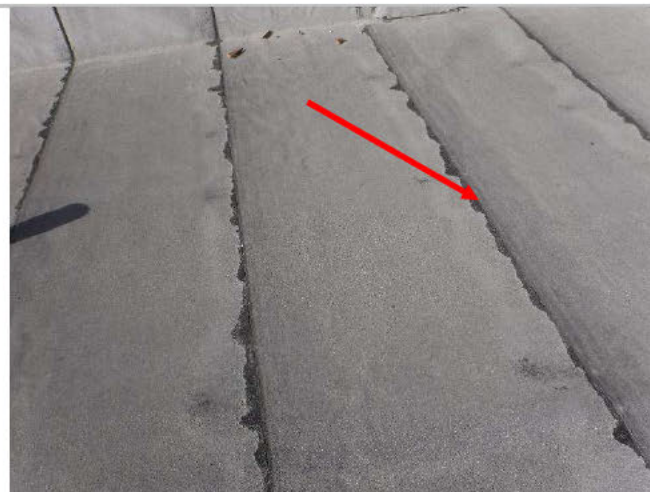
Photo #9 HA 25: Asbestos-containing Asphalt Roof with Black Tar.

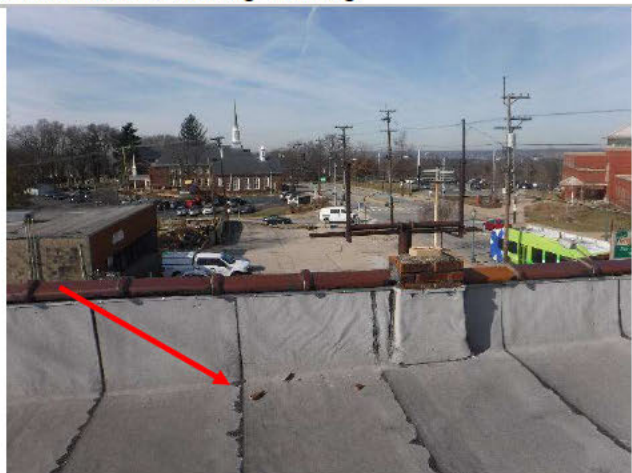
Photo #10 HA 26: Asbestos-Containing Asphalt Flashing with Black Tar.

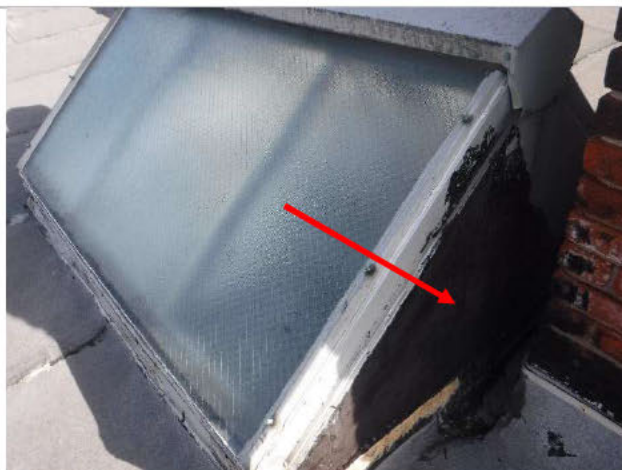
Photo #11 HA 27: Asbestos-containing Black Roof Patch.

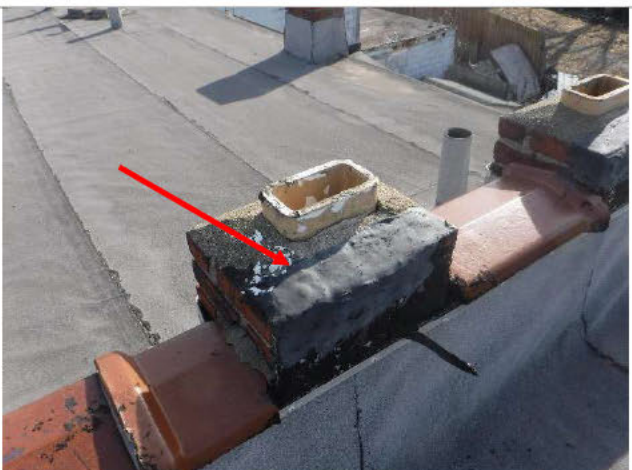
Photo #12 HA 29: Asbestos-Containing Tar/Mastic Beneath Non-Asbestos-Containing Grey Caulking.

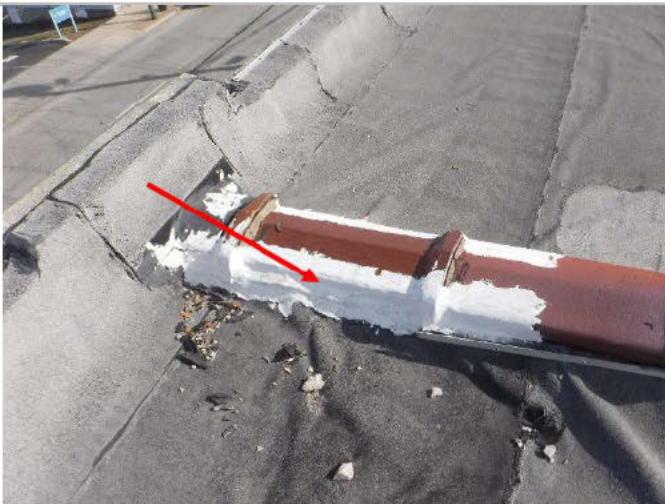
Photo #13 HA 30: Asbestos-containing Black Mastic Beneath Non-Asbestos-Containing White Roof Patch.

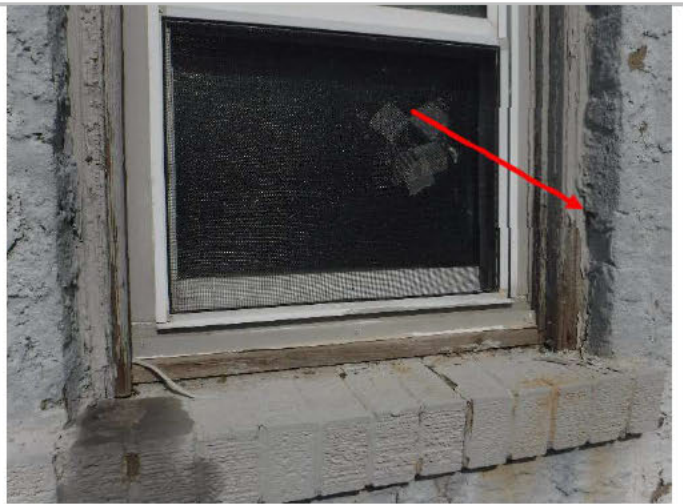
Photo #14 HA 33: Asbestos-containing Tan Window Caulking Beneath Non-Asbestos-Containing Exterior Grey Caulking.

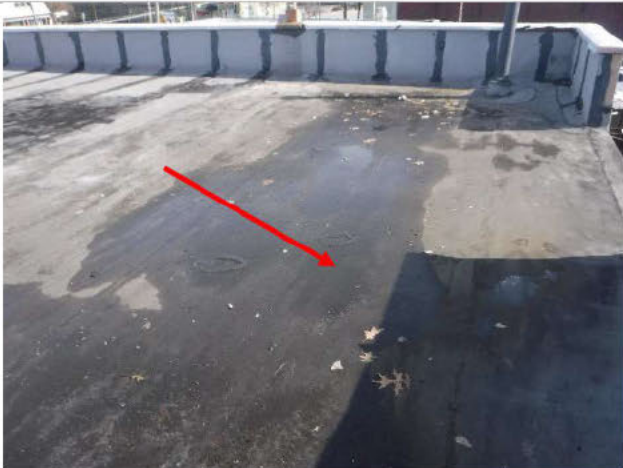
Photo #15 HA 34: Asbestos-containing Asphalt Roof with Non-Asbestos-Containing Tectum Gypsum Board.

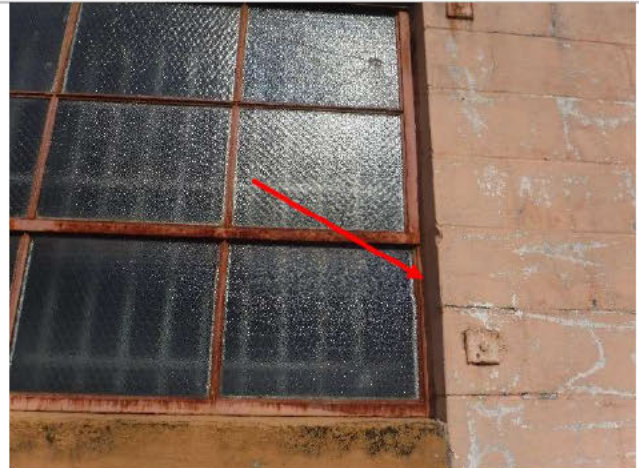
Photo #16 HA 44: Asbestos-containing Exterior Grey Window Caulking.

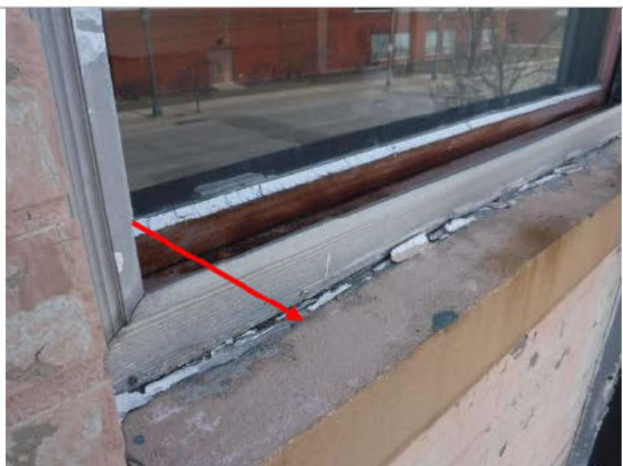
Photo #17 HA 48: Asbestos-containing White Exterior Window Caulking.

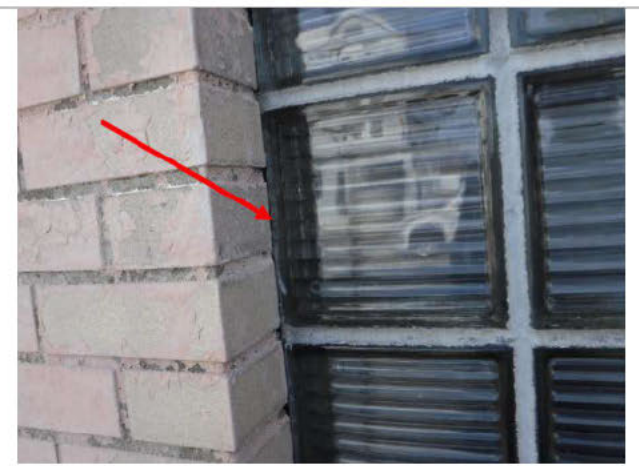
Photo #18 HA 52: Asbestos-containing Grey Exterior Window Caulking on Block Windows.

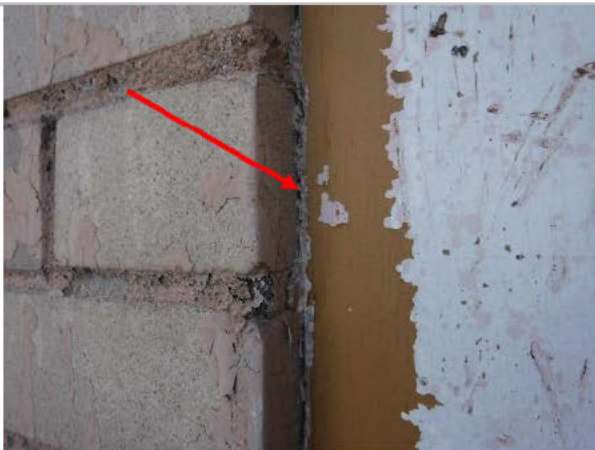
Photo #19 HA 53: Asbestos-containing Exterior Grey Door Caulking.

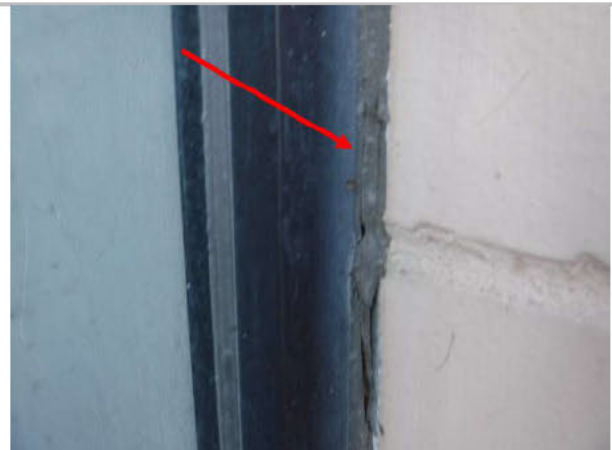
Photo #20 HA 56: Asbestos-containing Grey Exterior Window Caulking.

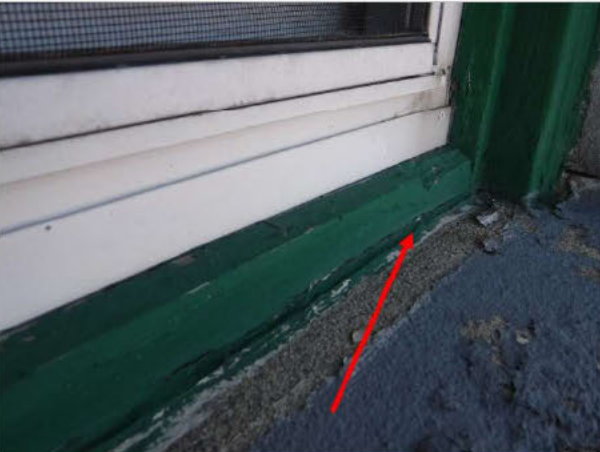
Photo #21 HA 57: Asbestos-containing Grey Exterior Window Caulking.

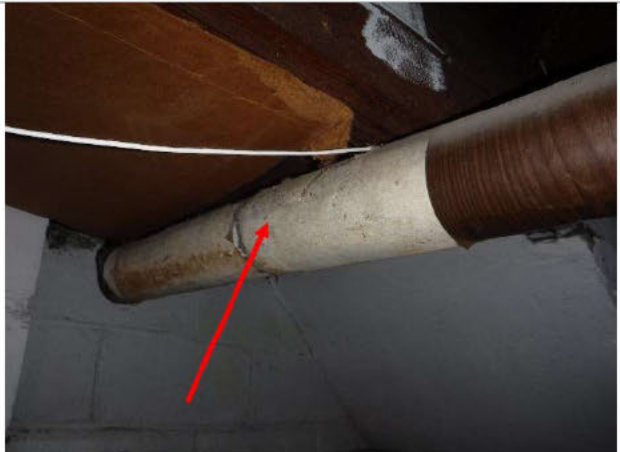
Photo #22 HA 67: Asbestos-containing Aerocell Pipe Insulation.

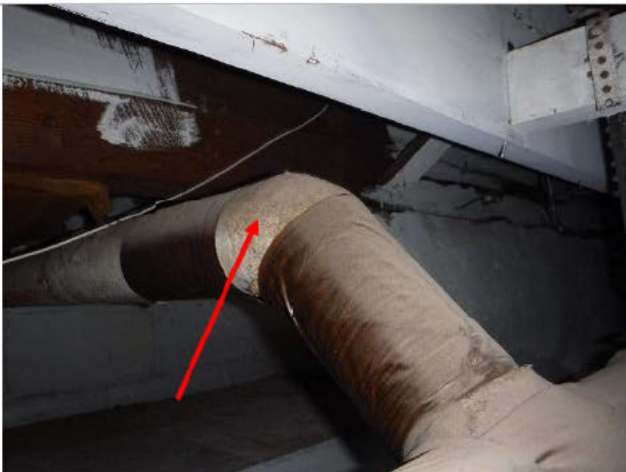
Photo #23 HA 68: Asbestos-containing White Hard Pipe Fittings.

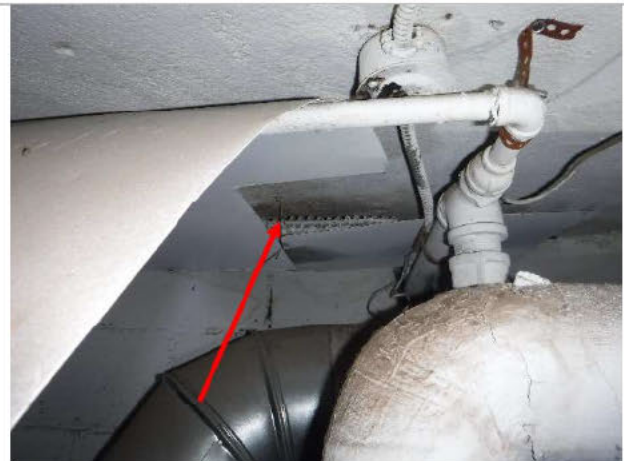
Photo #24 HA 72: Asbestos-containing Corrugated Insulation Board.

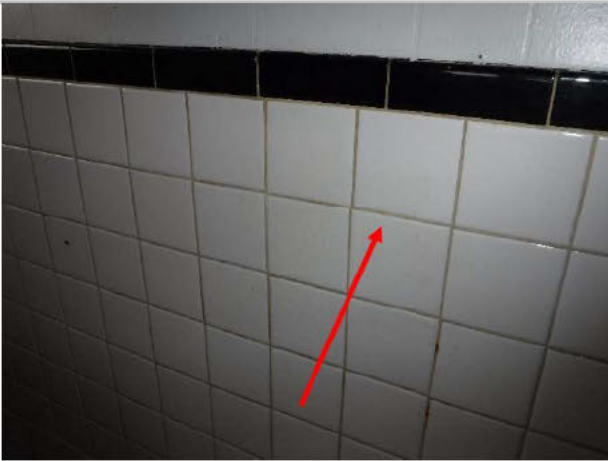
Photo #25 HA 93: Asbestos-containing Brown Mastic Beneath Non-Asbestos-Containing 2"x4" White Ceramic Wall Tile and Grout.

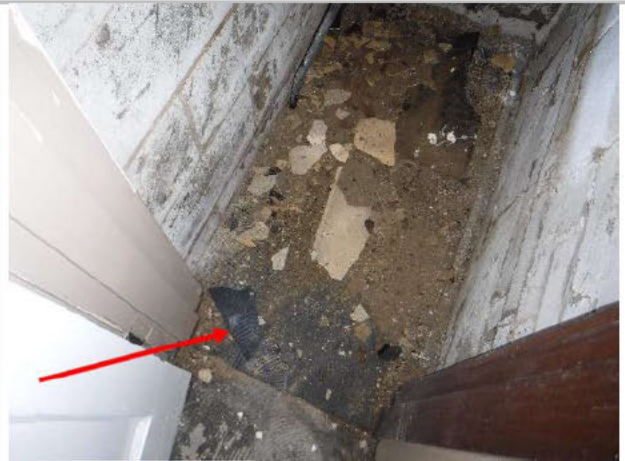
Photo #25 HA 93: Asbestos-containing Black Floor Tile with Non-Asbestos-Containing Black Mastic.
